## ASSEMBLY INSTRUCTION SHEET

# 5.5" L-H DROP UNIVERSAL ATLAS SHIFTER

**P/N: 303000L**  
**P/N: 303001R**

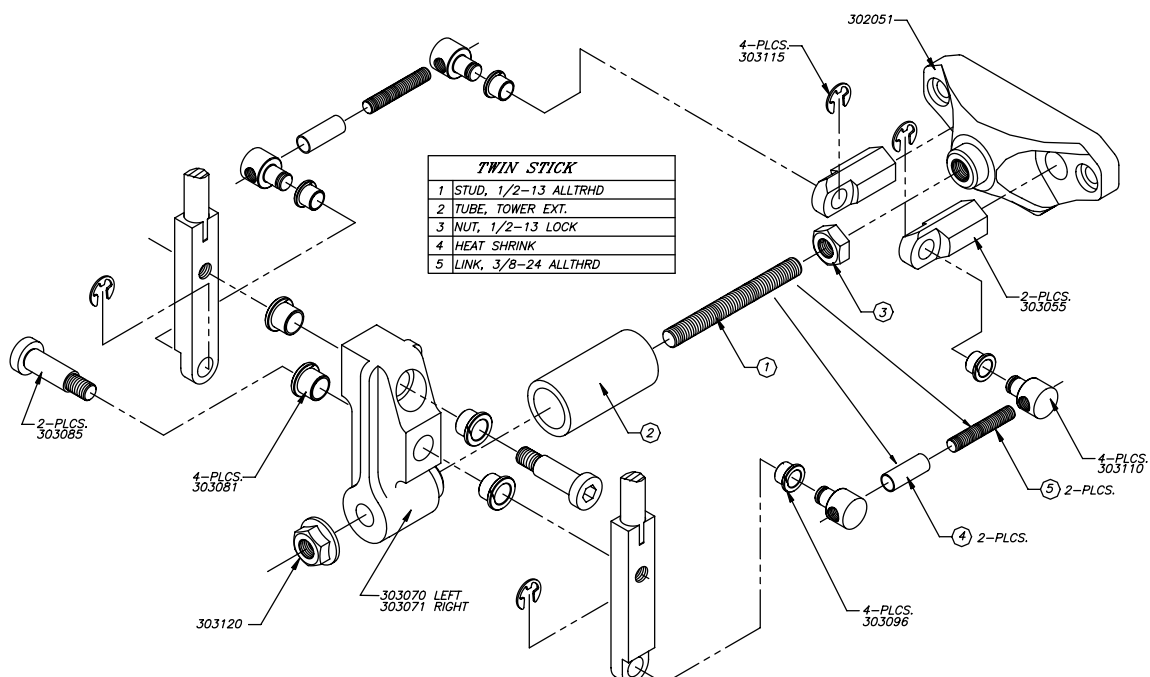
The shift tower in this photo as shown would index onto the D.O.M. tubing and would fit a left drop case. Right drop cases would require the tower to be flip to the other side to index over the D.O.M. tubing.

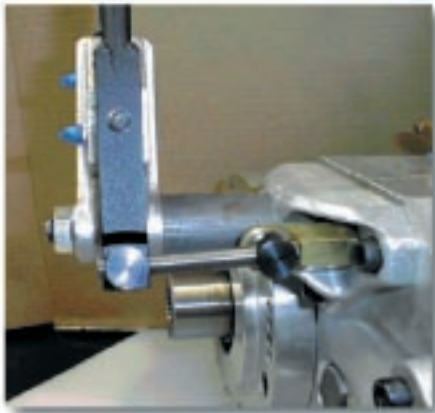
Atlas shifter problem check list: When installing the twin stick shifters, there are a few key areas that must be addressed. One of the most common difficulties we hear is that "my unit isn't shifting fully into one of the gear ratios". Incorrect adjustment of the shift handles to the linkage rods is normally the cause. With both shift rods in neutral, the linkage rod (connected to the shift handles) must be parallel with the aluminum shift tower. Refer to the photo left.
