## ***XJ AW4 ATLAS 4 SPEED SHIFTER***

## XJ AW4 ATLAS SHIFTER

**This Atlas shifter has been designed for the Jeep Cherokee XJ.**

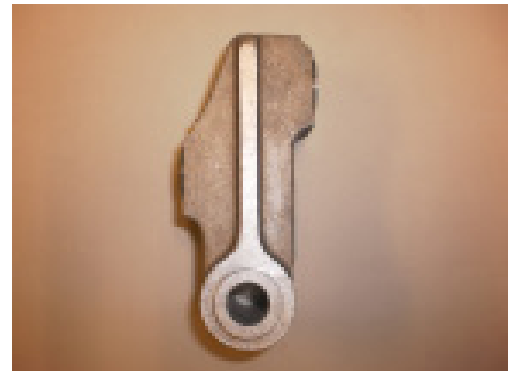
The shift tower in this photo as shown would index onto the D.O.M. tubing and would fit a left drop case. Right drop cases would require the tower to be flip to the other side to index over the D.O.M. tubing.

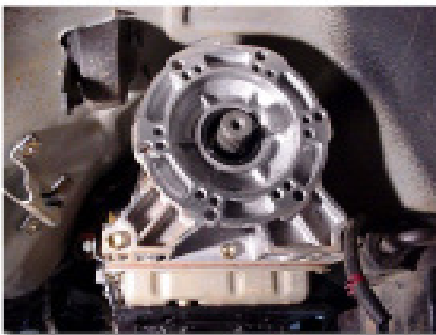
Rear view of the AW4 automatic.

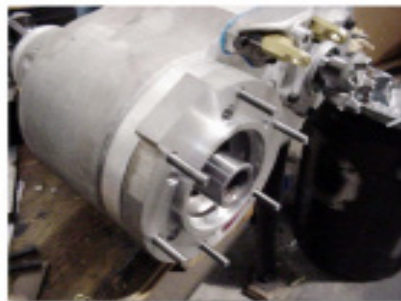
The stock output shaft protrudes .500" past the stock adapter housing. To achieve the proper spline engagement on the Atlas a 1" spacer is required, P/N 51-0404.

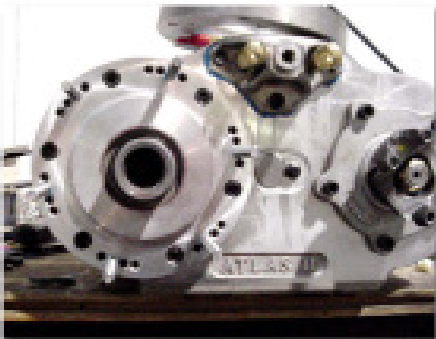
The photo (left) shows the rotation we used to obtain the proper shifter clearance.

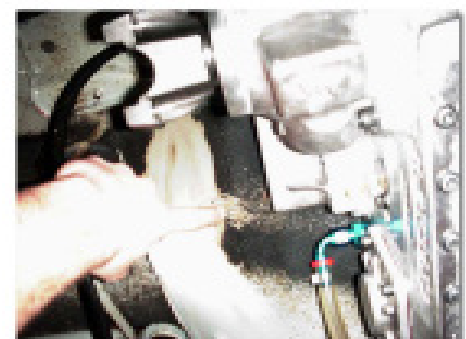
The photo (right) shows the minor body modification made for clearance on the Atlas.

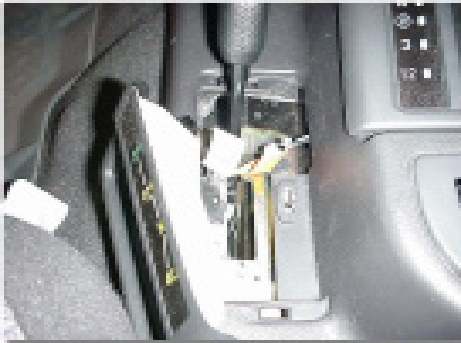
The photo (right) shows the Jeep console removed and the transfer case linkage removed

The stock console will require disassembly and the stock transfer case linkage will need to be removed.

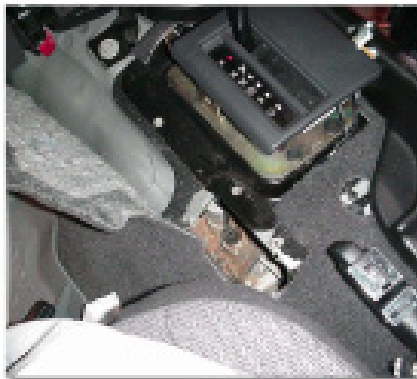
Floorboard modifications are necessary to fit the Atlas twin stick. This photo (below) shows 1" of material removed from the right side and front of the stock hole. (.500" needs to be removed from the left side)

Once the floorboard has been modified, it should look like the photo shown here (photo below).

Since the stock floorboard hole is longer than needed, we recommend using a piece of sheet metal to cover the rear 1" section of this stock hole. (photo shown below)

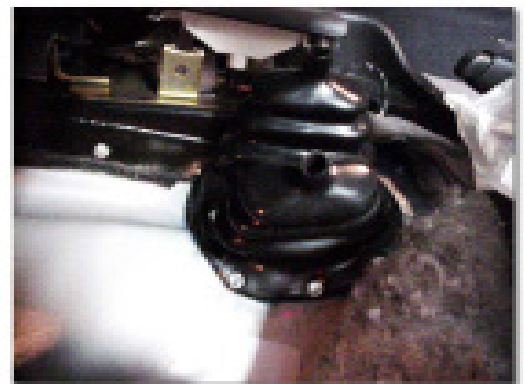
Test fit the Atlas shift handles. If proper clearance has been obtained, screw the rubber boot and ring to the floorboard. Note: The boot ring will need to be cut in half for proper fit to your floorboard.

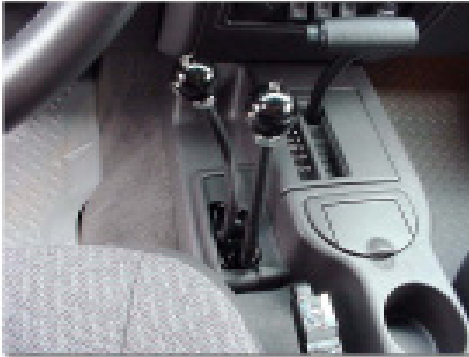
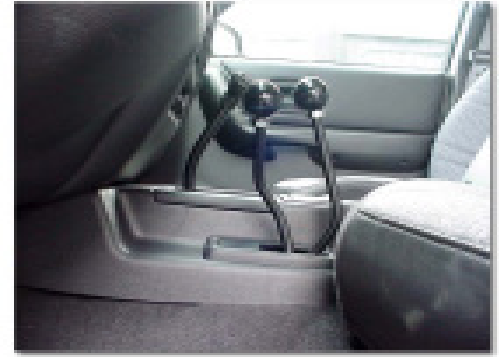
Since the stock transfer case shift indicator cover will not fit with the Atlas twin-sticks, we modified this cover. Remove the indicator panel and cut the plastic that supported the indicator panel. Ideally the plastic housing that snaps into the console is what your trying to retain. We purchased a small piece of black plastic

from a local stereo installation shop and cut it to fit our plastic housing. We heated it to fit the contour and glued it into position. We then cut new access holes in the black plastic to fit our twin sticks.
