BRONCO C4 ATLAS II SHIFTER

BRONCO ATLAS II SHIFTER

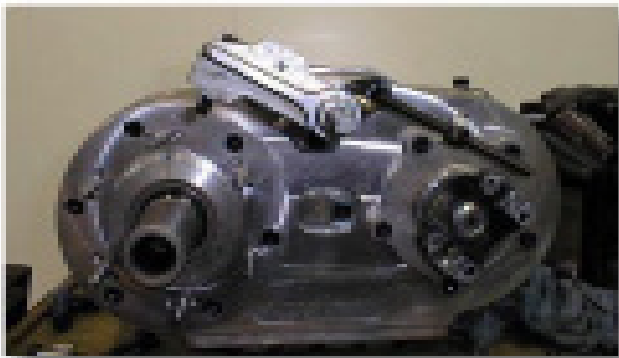
The shift tower in this photo as shown would index onto the D.O.M. tubing and would fit a left drop case. Right drop cases would require the tower to be flip to the other side to index over the D.O.M. tubing.

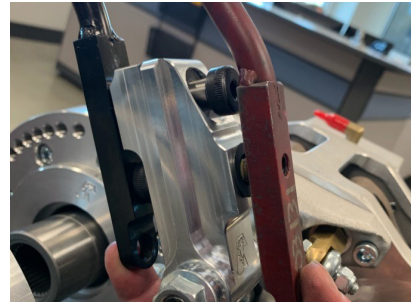
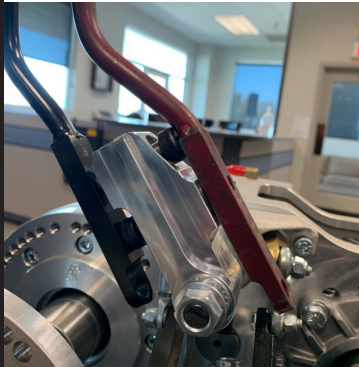
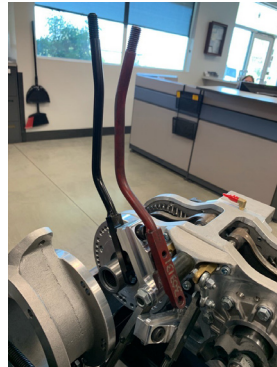
On the Bronco that we installed the Atlas transfer case into, the shifter tower rotation should look something like this.

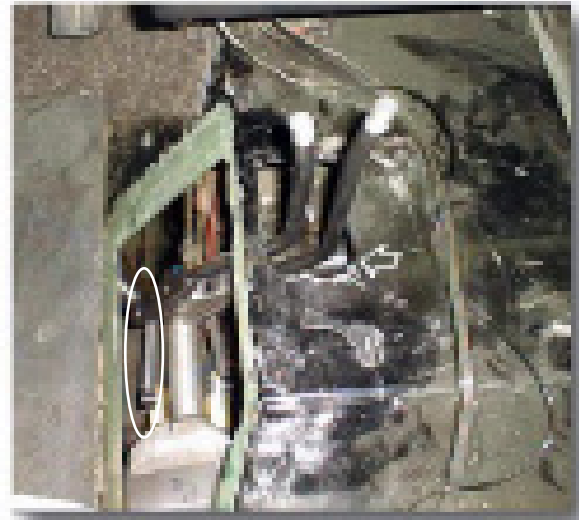
The Bronco handles installed on the Atlas

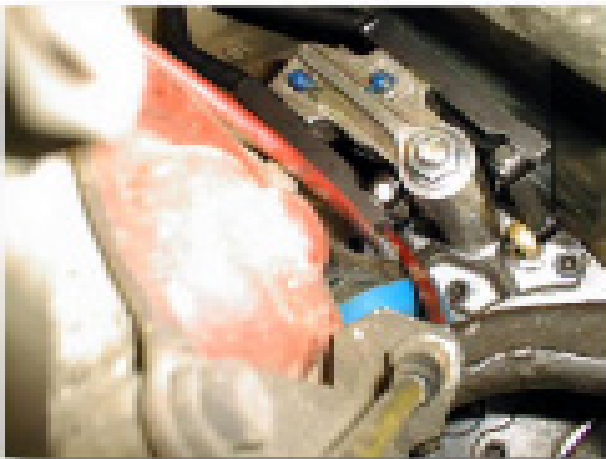
Inside the vehicle, we removed the side inspection cover for easier linkage installation. (Notice the brass shift rod rotation and the shift button configuration). Also, a small amount of material from the floor board was removed.

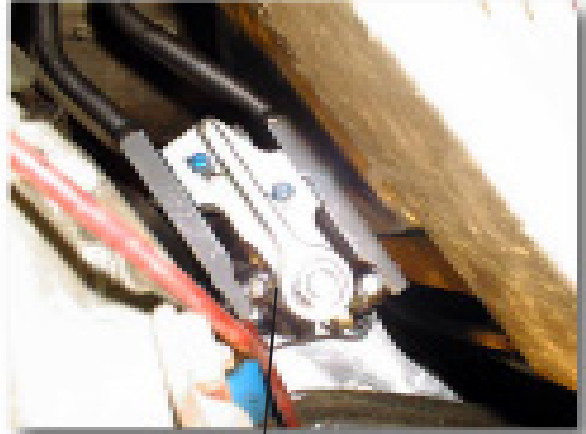
Looking back from the drivers side of the C4 transmission, this is how the shifter linkage should look installed in the vehicle.

This kit was designed to fit the stock shifter hole. On some applications, customers have modified their inspection cover and brought the shift handles through a new hole. (This may be necessary on some manual transmission applications).

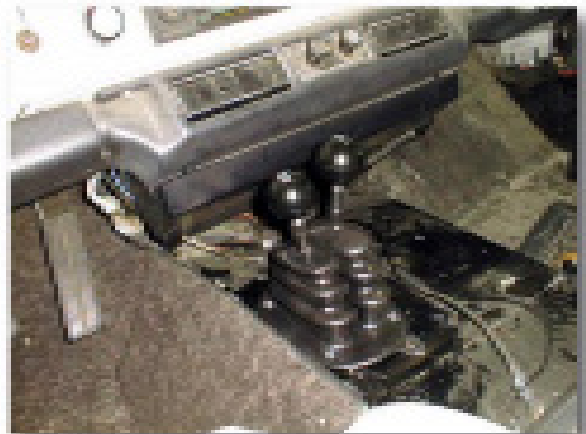
The new twin stick boot covers the stock transfer case hole.

The Atlas with C4 transmission final installation.

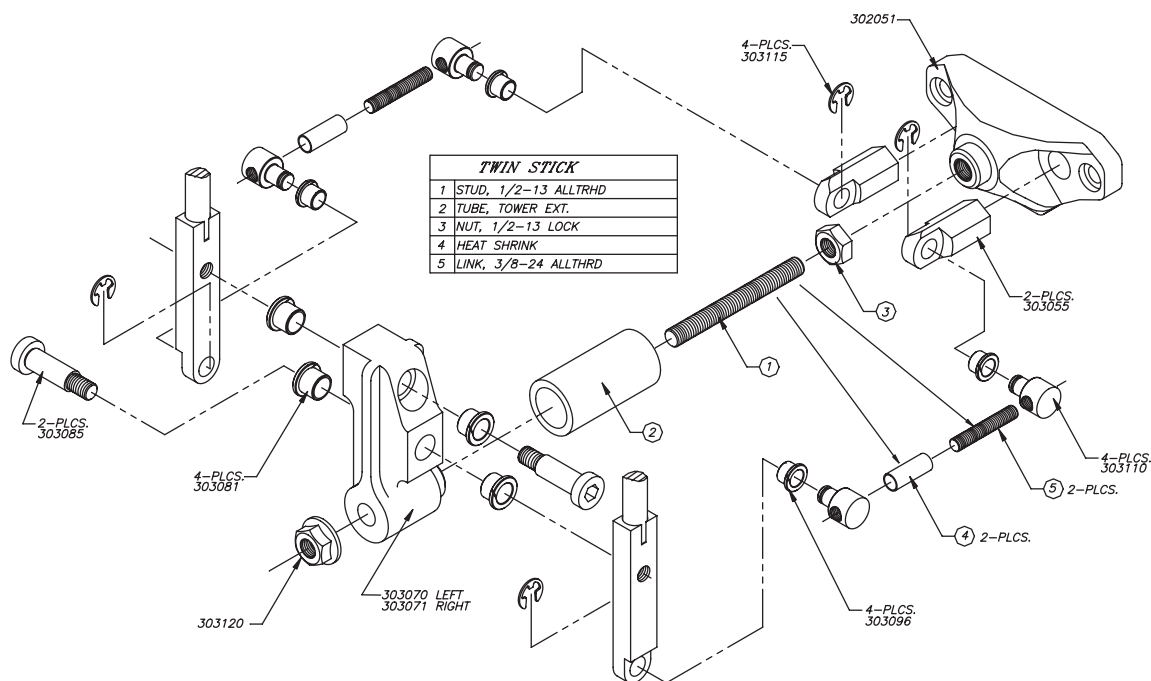
SHIFTER INSTALLATION (2sp and 4sp main case)

1. Install the shifter base to the face of the Atlas using the three S.H.C.S. 3/8"-16 x 1". These bolts have a sealant patch that will prevent leakage on the threads. This should be done before the Atlas is installed into the vehicle.

2. Install 1/2"-13 all-thread and jam nut to the shifter base.
3. Slide the shifter tower along the all-thread stud until the shifter arms are at the center of your stock floor cutout.

4. Measure between the tower and the base to obtain the correct extension tube length.
5. Remove the tower and install the extension tube.
6. Assemble the shift handles to the shift tower.

7. Install the shift tower assembly to the extension tube using the lock nut on 1/2"-13 all-thread to secure.
8. Install the brass shift rod ends to the Atlas shift rods. Teflon tape should be used on the threaded portion of the shift rod.

9. With the Atlas in neutral and the shift handles parallel with the shift tower, measure the distance for the linkage rods.
10. Connect the shift buttons and heat shrink tubing to the 3/8"-24 all-thread at the distance measured. Make sure that the all-thread is flush with the outside edge of the shift button. Cut all-thread if necessary.

11. Assemble the linkage rods to the shift handle and brass portion of the shift rod and verify the shift handles are parallel to the tower.
12. Install the e-clips to retain the buttons to the mating parts.

13. Make sure the brass shift rod ends are not too tight. They should be finger tight.
14. Modify the floorboard if necessary.
15. Install the rubber boot and boot ring to the floorboard. (Note: On some twin stick configurations, the boot ring may need to be cut in order to fit around the Atlas twin sticks).

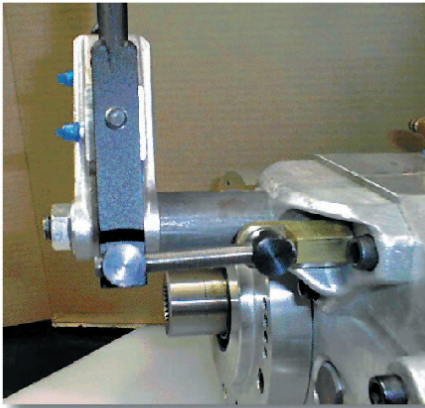
Atlas shifter problem check list: When installing the twin stick shifters, there are a few key areas that must be addressed. One of the most common difficulties we hear is that "my unit isn't shifting fully into one of the gear ratios". Incorrect adjustment of the shift handles to the linkage rods is normally the cause. With both shift rods in neutral, the linkage rod (connected to the shift handles) must be parallel with the aluminum shift tower. Refer to the photo left.

Another concern that we've heard is that "my Atlas seems to be hard to shift". This problem could be one of two areas. The brass shift rod ends that the shifter linkage rods connect to are too tight, causing a binding effect on the shifter linkage. The brass shift rod ends should be installed until tight, then loosened enough to align to the shifter button.

The last of the most common dilemmas we hear is that "the shifter linkage came apart while in operation". The area in question is the all-thread linkage rods. These rods fit into the two shift buttons. To prevent the all-thread from unscrewing out of the shift buttons, a portion of the heat shrink tubing should have been installed (o-rings on a TJ automatic). The heat shrink tubing or o-rings act as a jam nut to prevent the all-thread from unscrewing. **DO NOT** use a jam nut on these linkage rods because it will cause binding of the shifter linkage.
