ATLAS 2 SPEED RACER REBUILD KITS

P/N AB2000 EARLY ATLAS

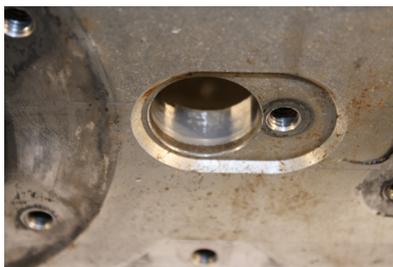
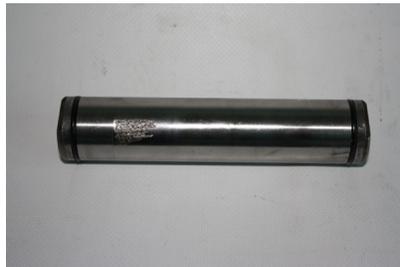
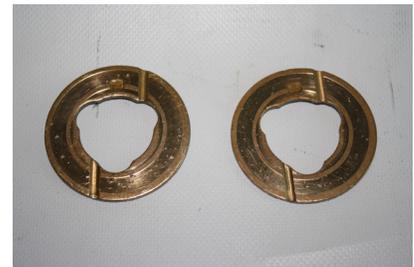
In the racing applications these are the most common areas we see problems with the Atlas. One additional suggestion on regular maintenance is to look at removing the synchro rings, dogs, and springs. Please be aware that the shift block springs must be updated if the synchros are removed, P/N 300395 (2 each) P/N 300396 (2 each).

The cluster pin and its contact area on the case is the most important area to inspect. The cluster pin should be smooth without any ridges on the shaft; the case should have nice smooth round bores. The high horsepower rigs that are on and off the throttle numerous times during competition causes stress on the helix cut gears. After repetitive abuse, this starts to hammer on the case and the pin. The pin can be changed out for a new one; however, if the case bore gets oblong then a new case is the next step. If these items are ignored, the cluster gear will eventually be able to move enough to cause a gear alignment issue and complete gear box failure. One additional area that should be inspected and replaced when parts are showing wear is the cluster gear thrust washers. The thrust washers on the cluster gear are items that should be inspected and replaced if necessary since they keep the cluster gear in tolerance from thrusting back to front.
