P.O. Box 247, 4320 Aerotech Center Way
Paso Robles, CA 93447
Telephone: (800) 350-2223 Fax: (805) 238-4201
PAGE 1 OF 7 Page Rev. Date: 10-23-19
P/N: 344005

ZJ ATLAS 4 SPEED SHIFTER

NOTE: For the complete shifter installation procedures, please refer to the Final Installation section located in the Atlas manual.

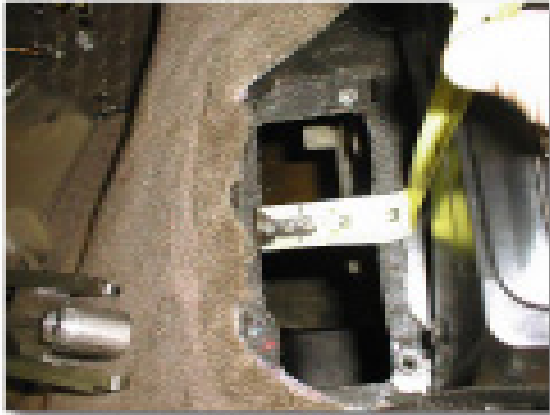
Stock hole width dimension.

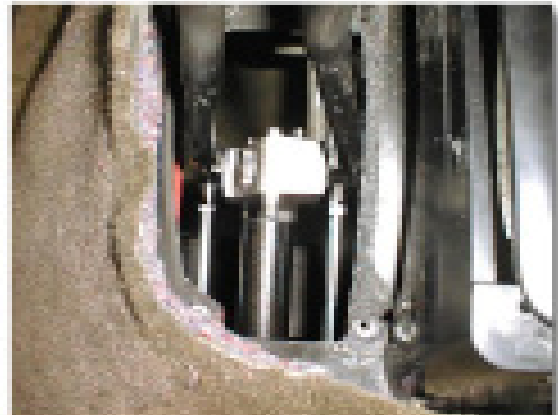
The stock hole opened up at the sides for shift lever clearance.

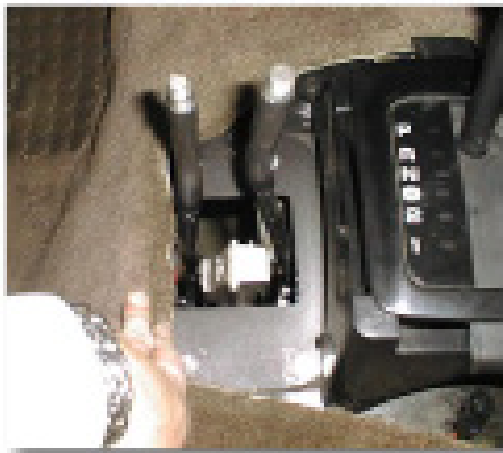
We opened up the stock hole for side clearance and made a plate from 16 gage sheet metal to fill the front & back open space. We also used the stock shifter mounting holes to secure the new plate. A second boot was included to permanently mount to the floor positioned inside of the console boot. (On our application, we cut the top bellow off the inner floor boot.)

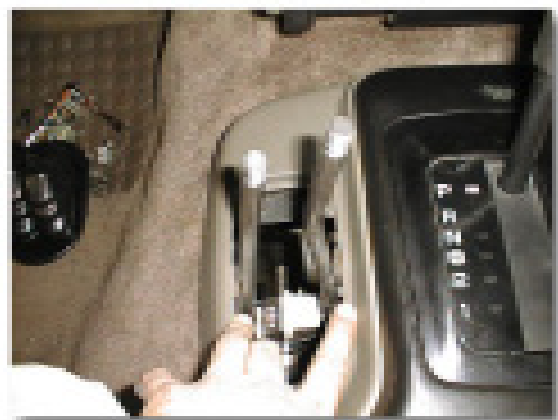
We chose the side-by-side twin stick configuration, positioned as far forward as possible. This gives you easy operation and eliminates confusion if the stock shifter plate were left in place.

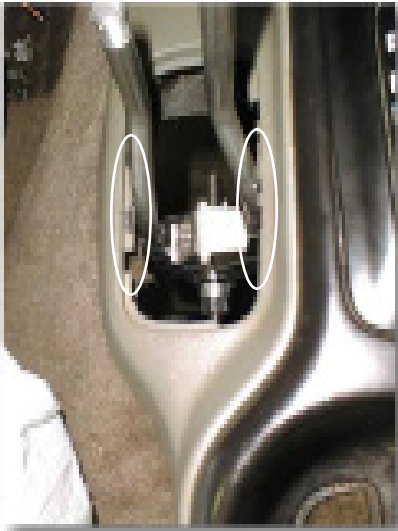
The plastic console was opened up by removing the center section of the support tabs. Notice the circled areas near the levers. You need enough room for the boot thickness, so remove the support lip and round the edge to the outer inside profile of the console slot.

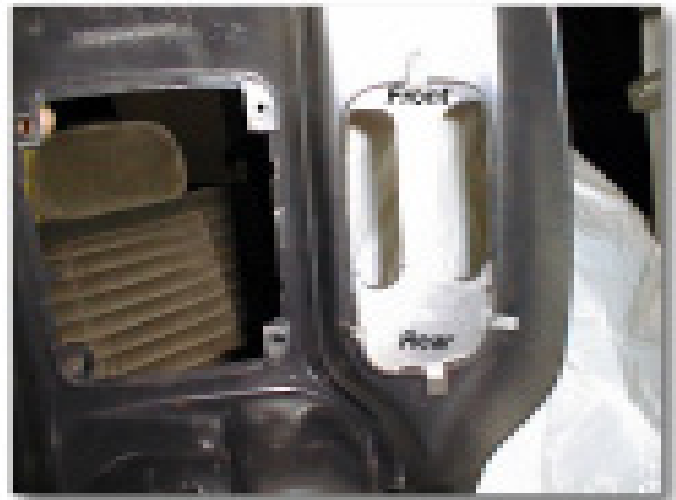
An inside shot of the stock console opened up for lever & boot clearance, and new metal support plate with the tabs bent to secure it into position. **(See last page of this instruction sheet for template of new panel).**

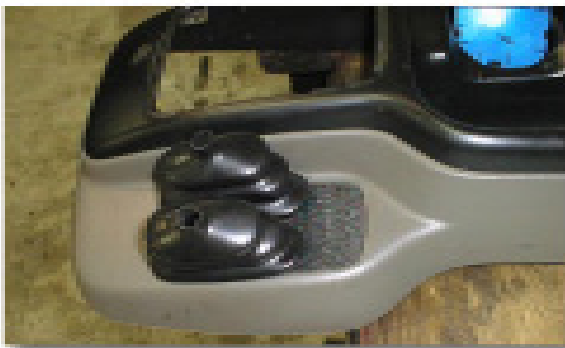
With the metal plate in position and a new panel made from ABS to match the metal plate shape, the outer (cosmetic) boot can be installed. **(Note: A good source for the ABS textured plastic is usually found at your local stereo shop).**

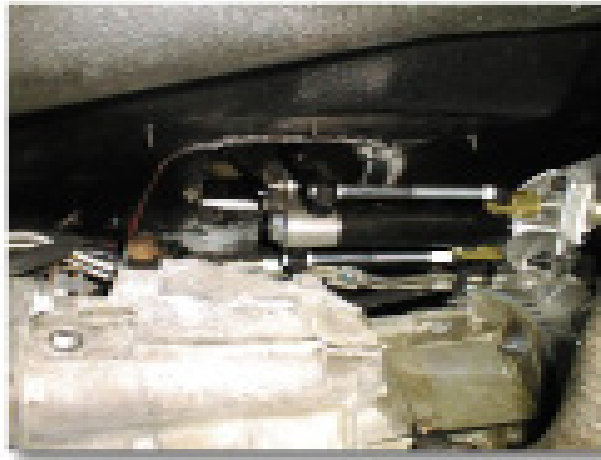
With the Atlas in neutral, adjust the links so that the levers are parallel to the shift tower casting at the lever pivot point.

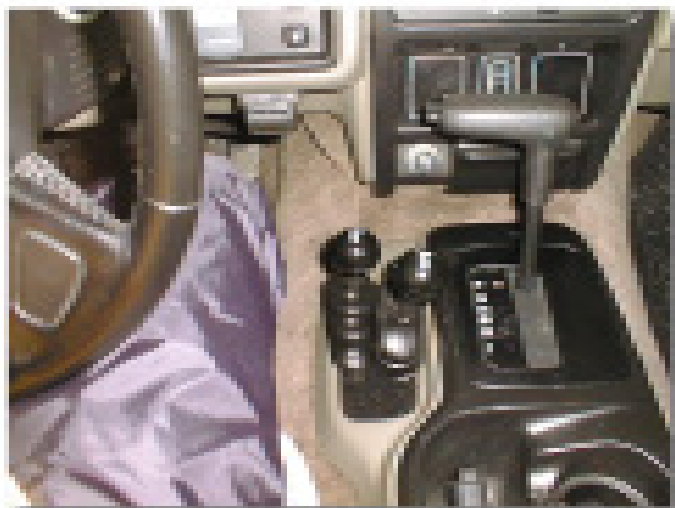
The final installed components with the Atlas transfer case in 2WD High position.

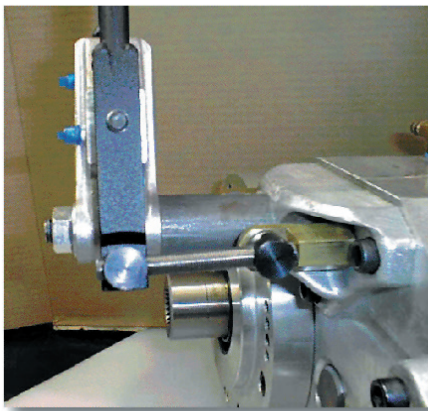
Atlas shifter problem check list: When installing the twin stick shifters, there are a few key areas that must be addressed. One of the most common difficulties we hear is that "my unit isn't shifting fully into one of the gear ratios". Incorrect adjustment of the shift handles to the linkage rods is normally the cause. With both shift rods in neutral, the linkage rod (connected to the shift handles) must be parallel with the aluminum shift tower. Refer to the photo left.
